# Watermain Replacement Program

WAT24001

AS PART OF THE TAY TOWNSHIP  
2024 CAPITAL BUDGET

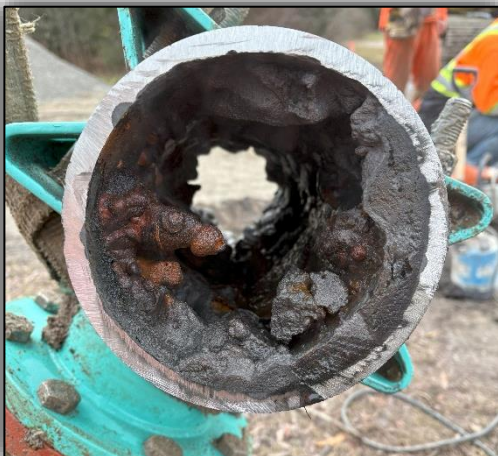
*Buildup of corrosion in the existing cast iron pipe – this pipe is abandoned and no longer in use.*

- Approximately 700m of 150mm cast iron watermain replaced with new 150mm PVC watermain
- 16 new services and curb stops
- 8 new main valves
- 4 new hydrants
- Pressure testing and chlorination
- Connections to the Algoma Avenue, Second Avenue, Keewatin Avenue, and First Avenue watermains

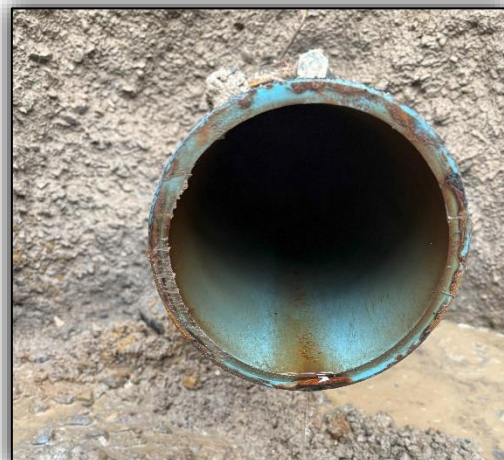
*An existing PVC pipe at Alberta Street and Algoma Avenue. No corrosion will be in PVC pipes!*

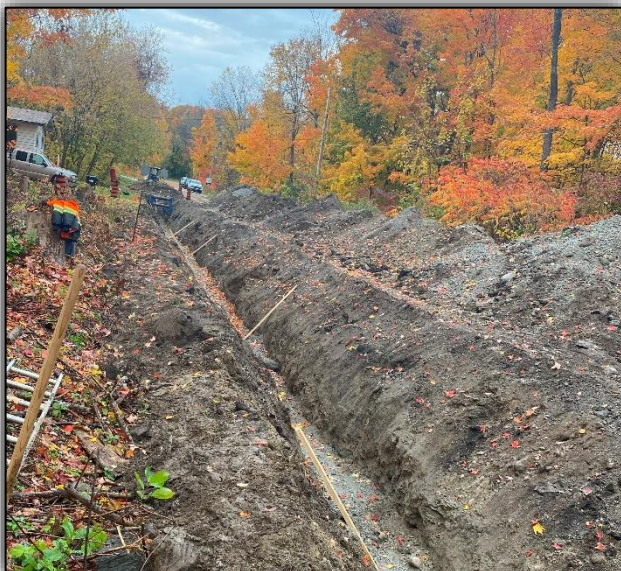
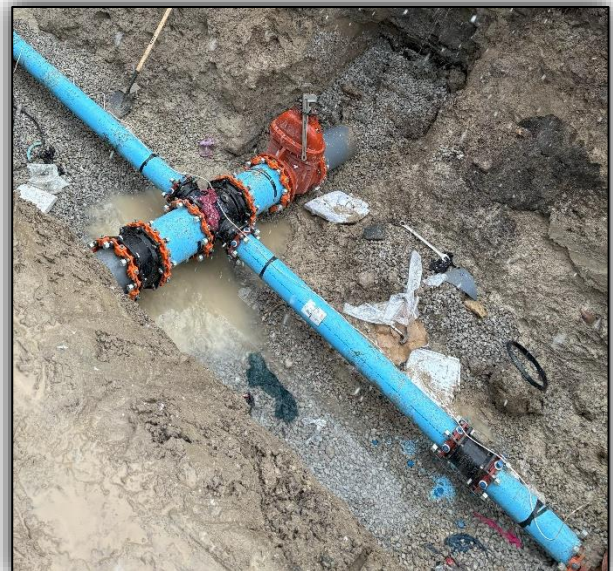
- New 150mm PVC watermain
- 44 new services and curb stops
- 5 new hydrants
- Connection to the Athabaska watermain
- Connection to the new Alberta Street watermain
- Pressure testing and chlorination

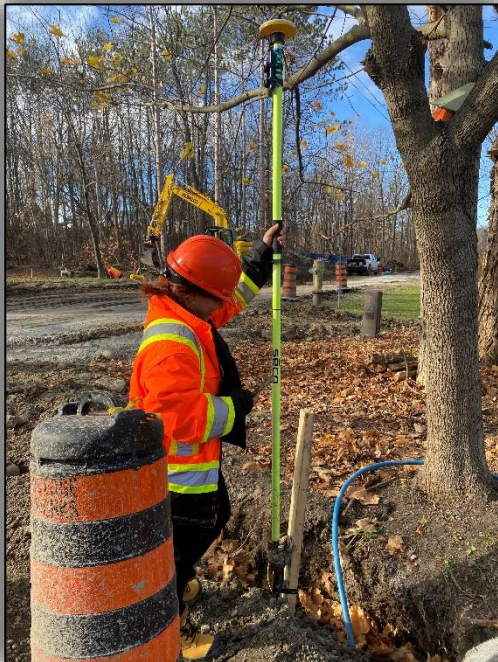
Township staff using the GPS unit for all curb stops, hydrants, and valves for our Geographic Information System (GIS) data and to create As-Built drawings.

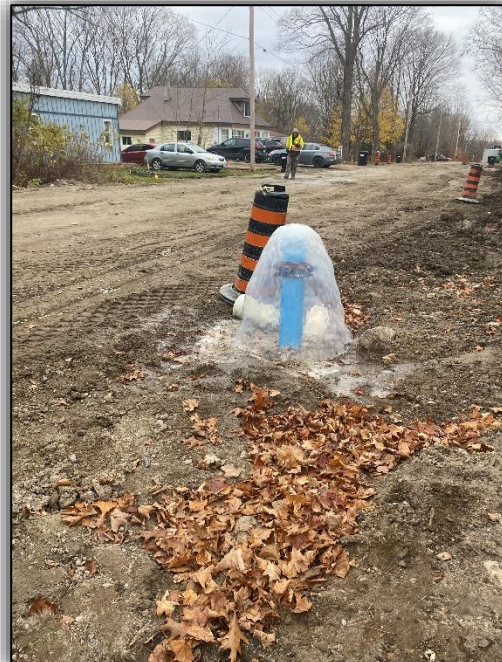
Chlorination testing using swabs on Fifth Avenue
